# Kirby Morgan Dive Systems, Inc.®

**Bulletin #7 of 2025. November 4, 2025**

## **⚠ SAFETY BULLETIN**

### **455 Balanced Regulator P/N 505-455: Required Attention**

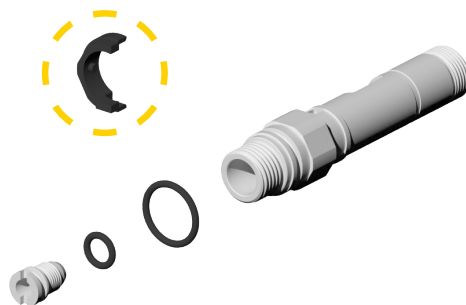
There have been two recent reports of the 455 Balanced Regulator P/N 505-455 failing to supply air on demand at depth, causing divers to switch to steady flow and abort the dive; one was in a training environment and the other in the field. In both cases, when the demand regulator cover was removed, the plastic bearing clip P/N 220-056 was broken. Additionally, through industry communication, we have been informed of broken bearing clips that did not impact the demand regulator's performance.

*The location of the P/N 220-056 bearing clip is shown above.*

Testing at Dive Lab has determined that the most likely cause of the clip failure is an excessive gap in the lever arm feet. This excessive gap could result from the lever bending during maintenance. The updated Kirby Morgan service module and Dive Lab technical training courses now stress the importance of maintaining the correct lever arm feet gap and include the revised, standard installation procedure.

If the lever arm's feet gap is too wide, it can exert pressure on the bearing clip and, over time, cause excessive wear. This wear may allow the lever arm's feet to expand enough to detach from the inlet valve. Extensive testing at Dive Lab with the bearing clip removed and the lever arm's feet set to the "proper gap" showed no performance loss or regulator failure. However, testing with the clip removed and the lever arm's leg gap larger than the acceptable range indicated that the inlet valve engagement could be lost.

**Immediate Action Required:** All users should check their 455 Balanced Regulator following the recommendations in this safety bulletin and the new technical guidance provided by Kirby Morgan in the 455 Balanced Regulator (455BAL) module, available under Support > Manuals and BlowAparts.

**Action Taken:** Kirby Morgan has revised the reassembly procedure for the 455 Balanced Regulator to emphasize the importance of the correct lever arm's feet gap and to include detailed instructions on reassembly and the significance of the lever arm's feet gap. Additionally, the technician training course will follow the modular manual instructions. Kirby Morgan is also creating an online step-by-step video to supplement the 455 Balance Regulator manual module. Dive Lab continues to conduct trials on the 455 Balanced Regulator in their lab, service center, and classroom, providing daily updates on their findings. Over 400 function tests on both correct and incorrect reassembly of the main tubes have been
