# Kirby Morgan Dive Systems, Inc.®

## Safety Bulletin #1 of 2007. March 1, 2007 Helmet Shell Repair Caution

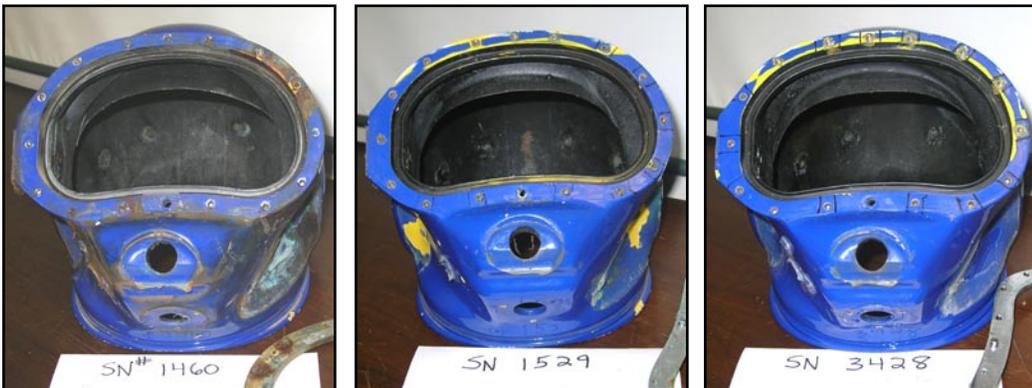
A visual inspection inside of all three helmets showed an obvious irregular finish around the regulator mount area. Once the paint was removed around the irregular area it was noticed that the whole lower section of the helmet had been previously removed and replaced with non-laminate filler.

*This is how the three stripped helmets appeared when they were received by the repair facility.*

It was obvious that someone had performed extensive modifications to the helmets for some other use by completely changing the front end of the helmets. They then attempted to put the helmets back into their original configuration as SuperLite 17B's.

These three helmets may not be the only ones that have been modified in this potentially dangerous way. Anyone noticing an irregular finish on the inside around the regulator mount as shown in the pictures, should not use the helmet and should immediately contact a KMDSI dealer or KMDSI. The helmets in question all came from the UK, however because of the international nature of commercial diving all users should use caution and carefully check any previously acquired used helmets.

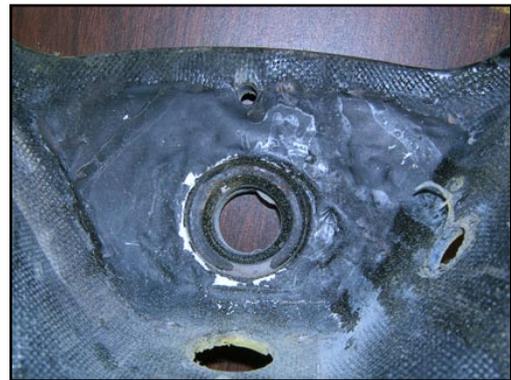
*The interior of one of the painted helmets shows obvious sub-standard repair work.*

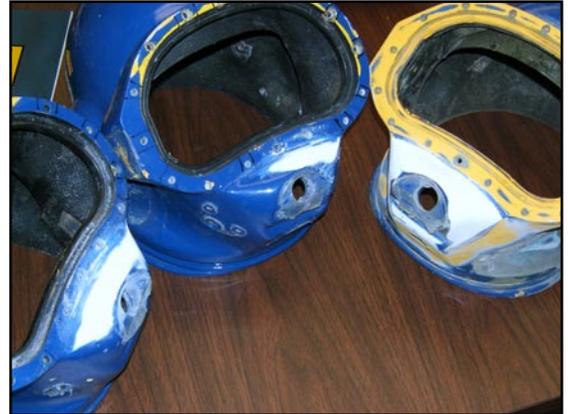
*The unauthorized paint job on these helmets concealed repairs performed with sub-standard materials.*

KMDSI has always discouraged painting of fiberglass helmets because there is no way of telling what lies beneath the finish. Refinishing should only be done by a specifically trained and certified KMDSI fiberglass technician. All repairs should be well documented, including pictures. Certified KMDSI fiberglass repair technicians will only use polyester gel-cote for refinishing and will only perform fiberglass repairs on helmets that have a record of repair, or only after removing any unauthorized coatings and performing a proper inspection.
