Kirby Morgan Dive Systems, Inc.

Caution Notice # 1 of 2005 Regulator Assembly

Regulator assembly Part # 505-069

Kirby Morgan helmets and BandMasks

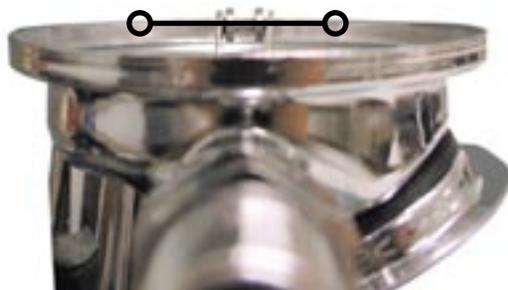
Fig.1

Correct position

In **Fig.1** note the parallel line drawn that represents the horizon. The roller lever's correct position is parallel to that.

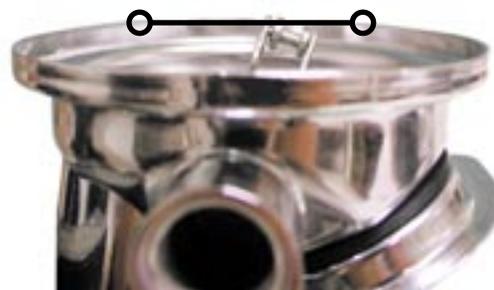
Fig.2

We have discovered an inconsistency with some of our regulator assemblies P/N 505-069 that were manufactured between January 1, 2005 to March 1, 2005. The tube that holds the inlet valve and lever arm on some of these units in this batch are misaligned and consequently the lever arm sits offset. This offset if large enough will not allow the lever to travel smoothly and may increase the inhalation effort. Regulators that have this configuration should be taken out of service and not used until they have been replaced.

InCorrect position

In **Fig.2** note the parallel line drawn that represents the horizon. The roller lever is out of position at an angle that exceeds three degrees.

If you discover that you have any of these products with the offset lever arm or inconsistent tube spacing, please send them back to KMDSI and we will replace them at no charge to you as soon as possible. If you have helmets and/or bandmasks with this incorrectly assembled regulator and you have an Authorized KMDSI Technician available, please remove the regulator and return it for replacement. We have corrected this situation and do not anticipate any further inconsistencies.
